The cost of doing it wrong

ESSENTIAL *MFG* CONCEPTS

Al Pucino, Ph.D.
www.essentialMFGconcepts.com
Apucino.emc@gmail.com

Potential Causes of Costly Production Issues

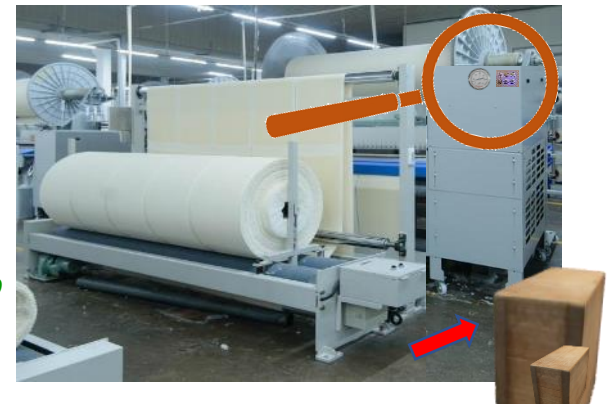
An employee tripped over a wooden crate placed in an aisleway adjacent to a machine on the manufacturing floor. The employee sustained serious head injuries resulting in:

A team was formed to investigate the occurrence and determined that a machine operator was responsible for placing the two crates in the aisle. The operator said that the gauge that needed to be read, and controller that needed to be adjusted were located high up on the equipment cabinet and therefore could not be read while standing on the floor.

Root-Cause: Access to the gauge and the controller was very difficult due to its location, forcing the operator to stand on the crates each time it was necessary to read the gauge and making the necessary machine adjustments.

Corrective Action: Relocate the gauge and controller to an operator-accessible location on the equipment so that there is no longer any need for the operator to climb.

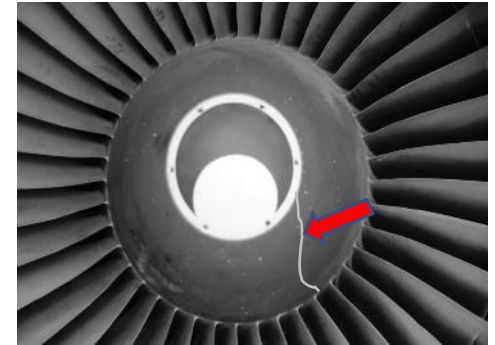
A series of superalloy engine rotors were found to be failing during fatigue testing by a rotor customer.

The vendor sectioned several failed rotors and verified that for each case, a fatigue crack originated from an existing internal defect. Measurements of the defect size indicated that failure occurred due to the defect's size being above the specification's allowed maximum limit.

Root-Cause: *The vendor examined their x-ray radiography inspection NDT records and found that none of the rotors shipped to the customer had any sign of defects. However, upon sectioning apparently “good” rotors, the vendor was shocked to find defects larger than those permitted by specification. The vendor assessed the sensitivity of their x-ray examination method and found that the wavelength being used was too large to detect the out-of-spec defects in the rotor.*

Corrective Action: *The vendor performed numerous calculations and determined for this product and customer they needed to use a shorter wavelength gamma ray instead of x-rays to detect the defects.*

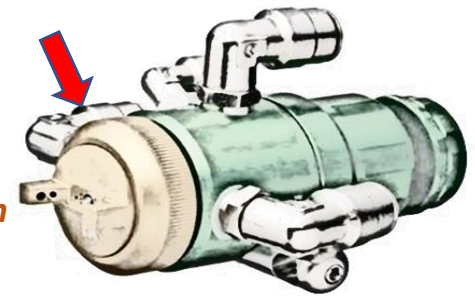
Ceramic Endcaps produced in a continuous in-line process failed to receive the required paint coating during this processing step. This has been a chronic problem.

Root-Cause: Two conditions were identified that would cause the problem of mis-coating: a blocked paint nozzle or a depleted paint supply vat.

Corrective Action: Two types of sensors were installed for the coating process. One sensor to detect if the paint reservoir is in the process of running out of paint, and a second sensor that examines the Endcap itself for the presence of paint. If activated, either sensor would shut down the machinery, and alert floor supervision to either refill the paint reservoir or take other action as required.
