The cost of doing it wrong

ESSENTIAL*MFG* CONCEPTS

Potential Causes of Costly Production Issues

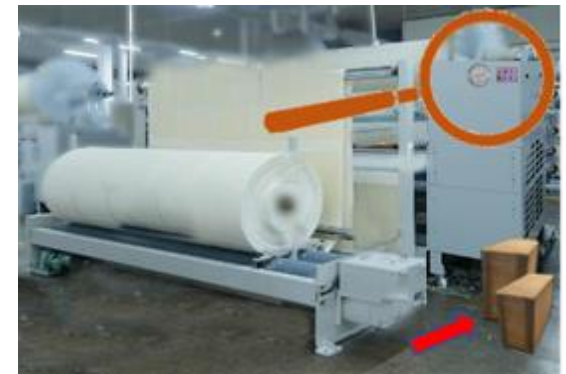
Corrective Action: Relocate the gauge and controller to an operator-accessible location on the equipment so that there is no longer any need for the operator to climb.

Root-Cause: Access to the gauge and the controller was very difficult due to its location, forcing the operator to stand on the crates each time it was necessary to read the gauge and making the necessary machine adjustments.

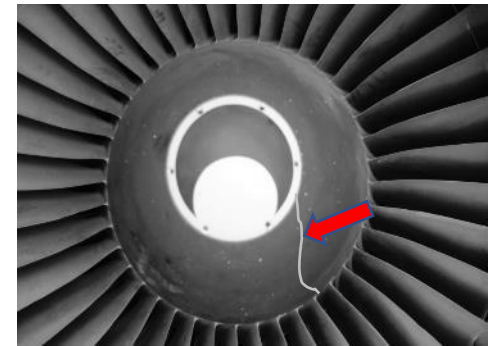
The vendor sectioned several failed rotors and verified that for each case, a fatigue crack originated from an existing internal defect. Measurements of the defect size indicated that failure occurred due to the defect's size being above the specification's allowed maximum limit.

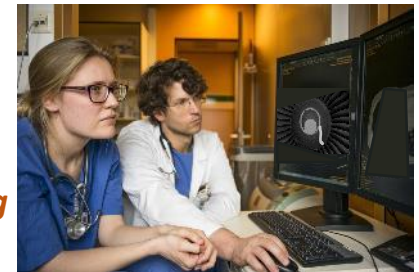
Root-Cause: *The vendor examined their x-ray radiography inspection NDT records and found that none of the rotors shipped to the customer had any sign of defects. However, upon sectioning apparently “good” rotors, the vendor was shocked to find defects larger than those permitted by specification. The vendor assessed the sensitivity of their x-ray examination method and found that the wavelength being used was too large to detect the out-of-spec defects in the rotor.*

Corrective Action: *The vendor performed numerous calculations and determined for this product and customer they needed to use a shorter wavelength gamma ray instead of x-rays to detect the defects.*

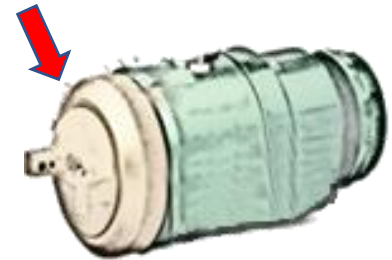
Corrective Action: Two types of sensors were installed for the coating process. One sensor to detect if the paint reservoir is in the process of running out of paint, and a second sensor that examines the Endcap itself for the presence of paint. If activated, either sensor would shut down the machinery, and alert floor supervision to either refill the paint reservoir or take other action as required.
